# *KOCH Marine Services<sup>Ltd.</sup>*

## *Vessel Condition Survey*

### *M.V. "Gentle Breeze"*

*Date: February 16, 2002*

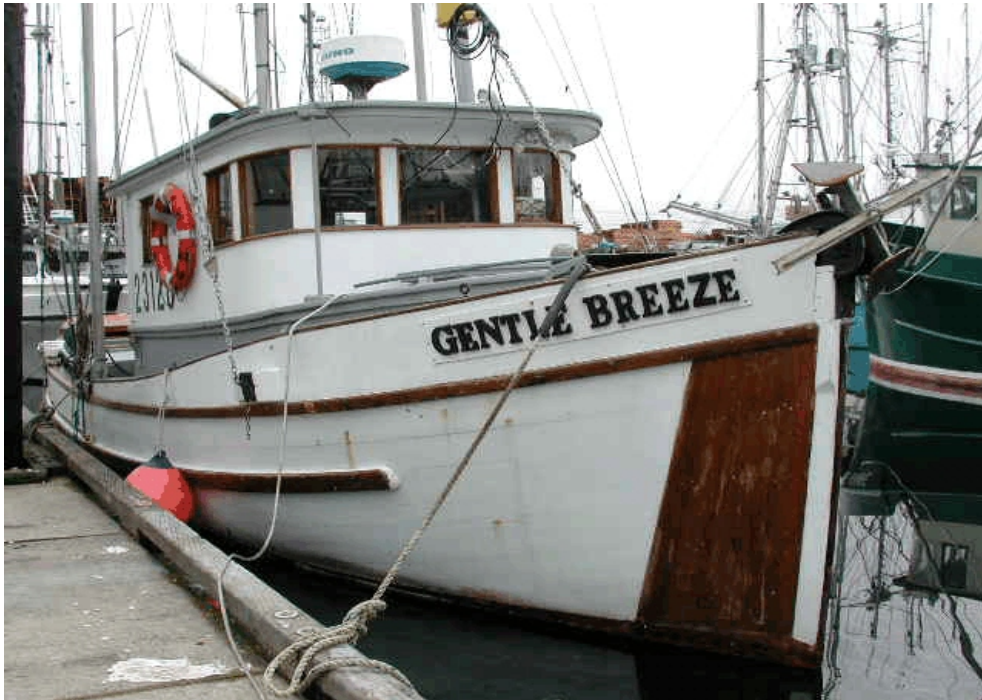
*Figure 1 Vessel overall, looking starboard aft*

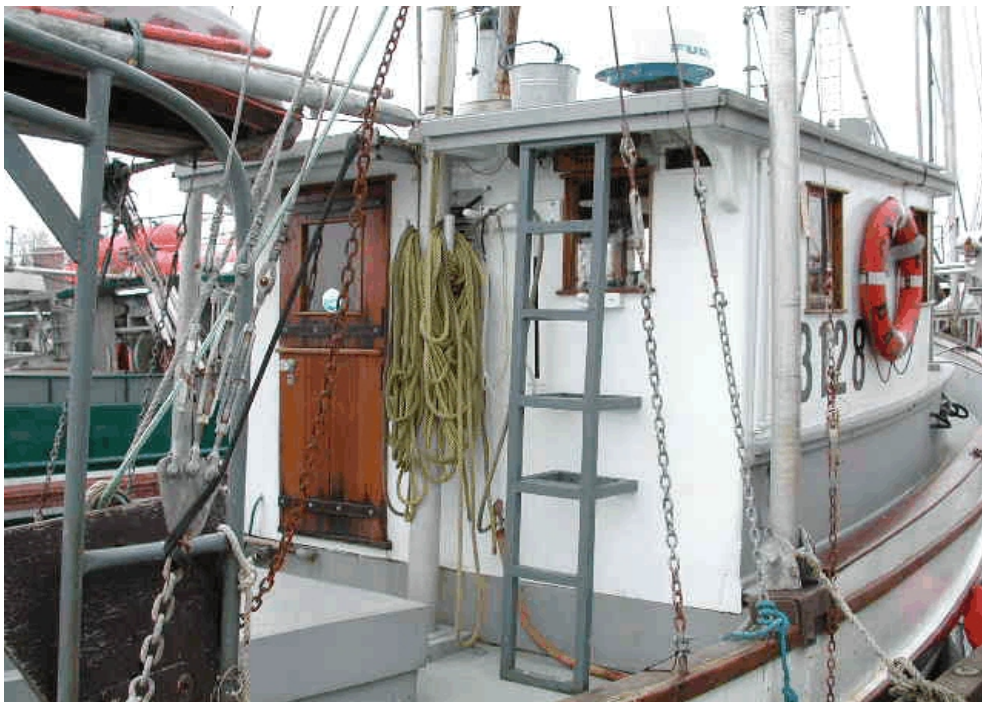
*Figure 2 Wheelhouse bulkhead overall*
